Investigation of the A-7 hook point attachment bolt loosening problem.

INVESTIGATION OF THE A-7 HOOK POINT
ATTACHMENT BOLT LOOSENING PROBLEM

Investigation of the A-7 Hook Point
Attachment Bolt Loosening Problem

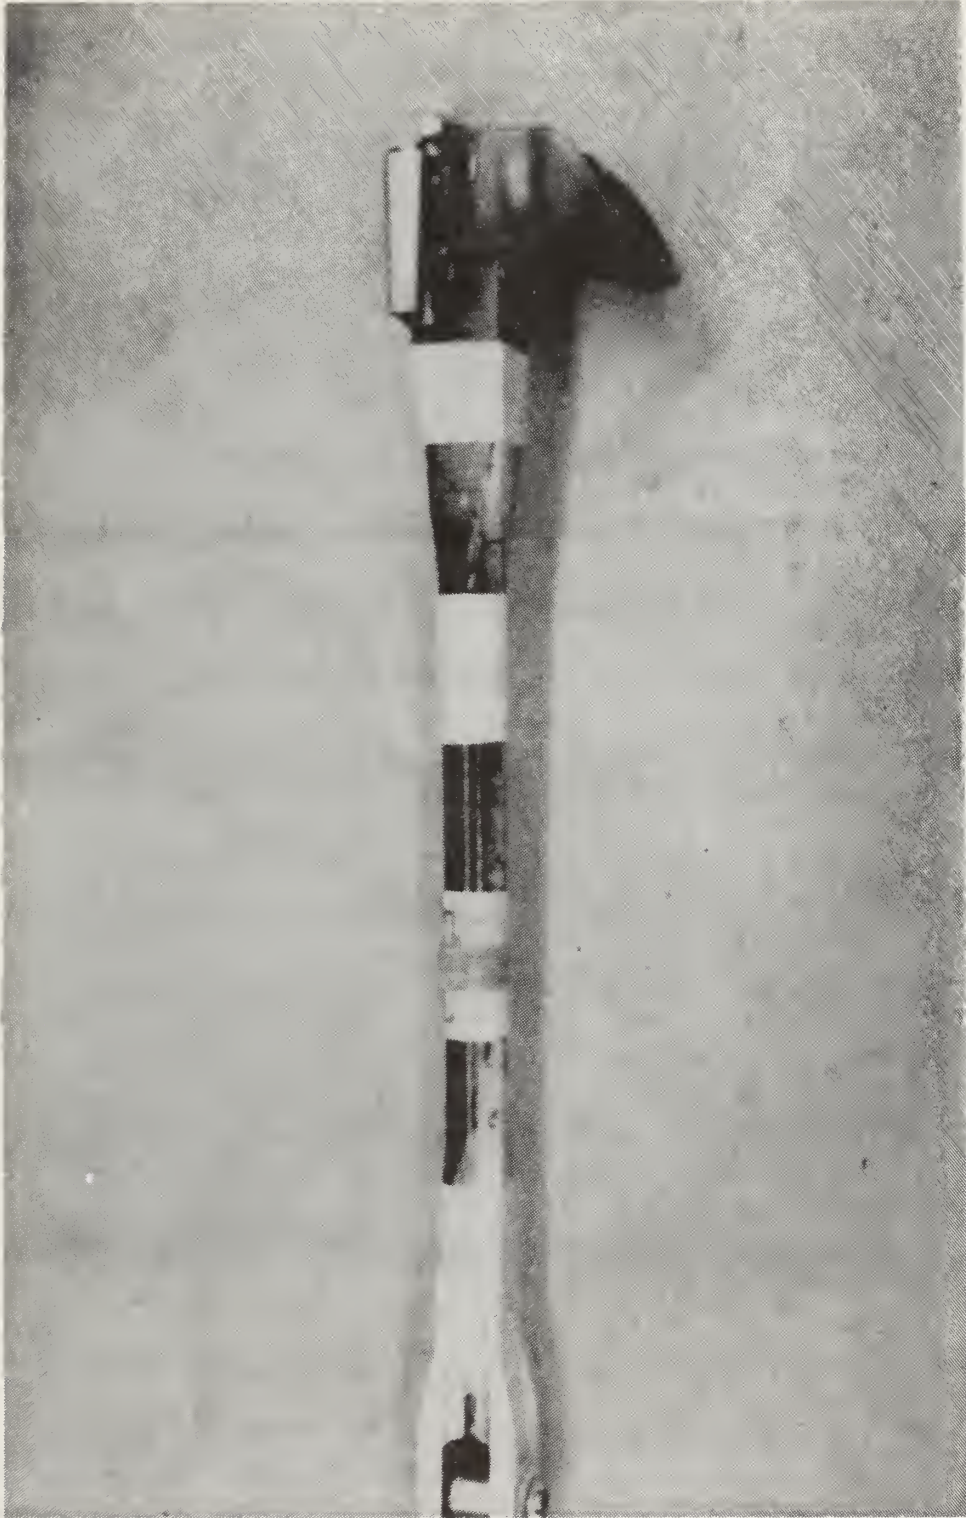
Figure 1. Complete arresting hook assembly.

The hook assembly and load path are illustrated in Figures 1 through 5. The design load path of the wire decelerating force is from the hook point to the shank through the large boss on the shank which mates with a receptacle in the hook point (Fig. 6,7). The attachment bolt was not designed to be a load carrying member and its sole purpose is to maintain a tight joint between the hook point and the boss of the shank.

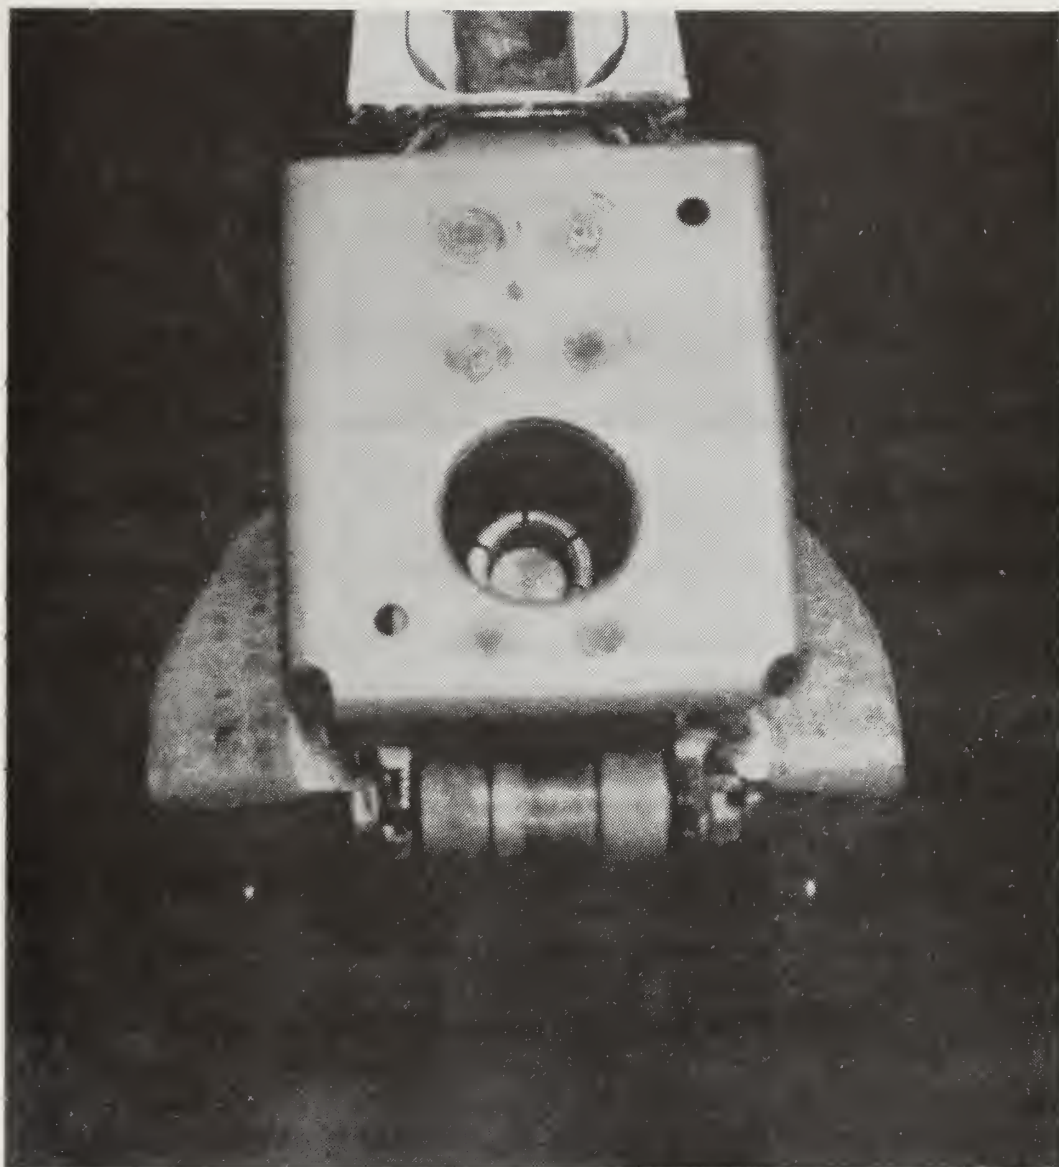
Figure 3. Top view of hook point-boss joint showing nut seated in the shank.

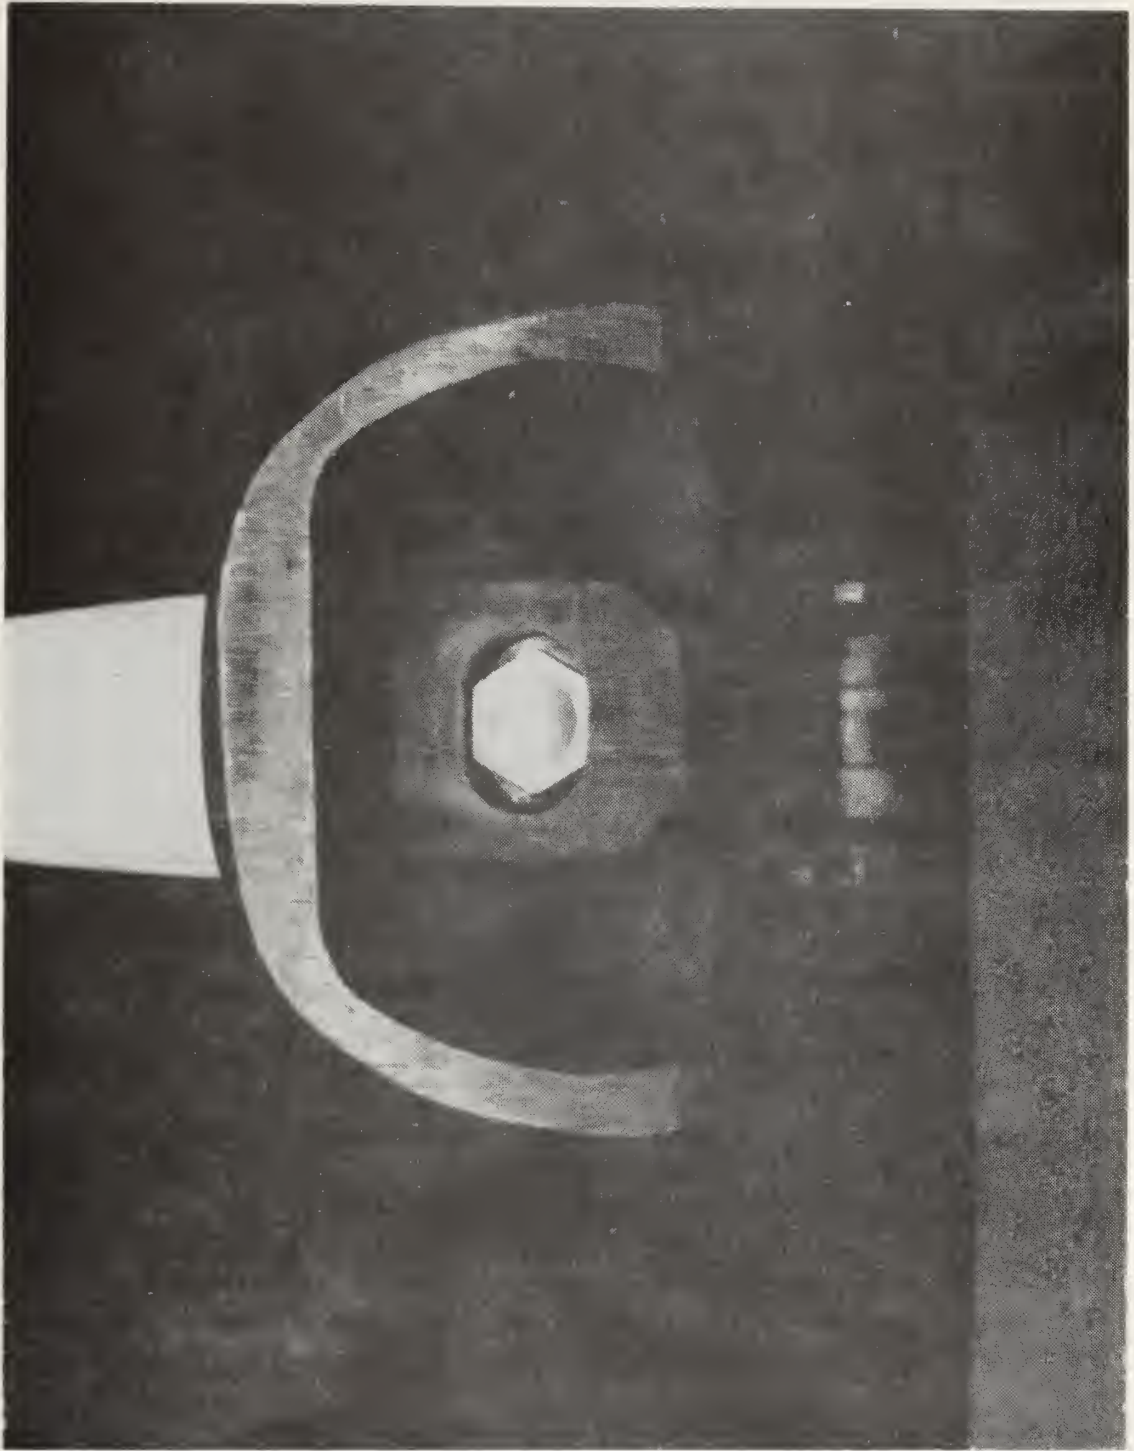
Figure 4. Bottom view of hook point-boss joint showing bolt head seated in the hook point.

Looking at the way the hook point attachment assembly is put together, Fig. 2, and how the bolt head is securely held in the hook point, Fig. 4, it can be seen that any sliding of the hook point relative to its seat on the shank results in transverse loading which Junker (Ref. 24) points out is the severest condition for the occurrence of self loosening. It was decided, based on the above, to investigate the possibility that large magnitude, low cycle, and low frequency hook loading of an arrested landing could cause the attachment bolt-nut combination to self loosen.

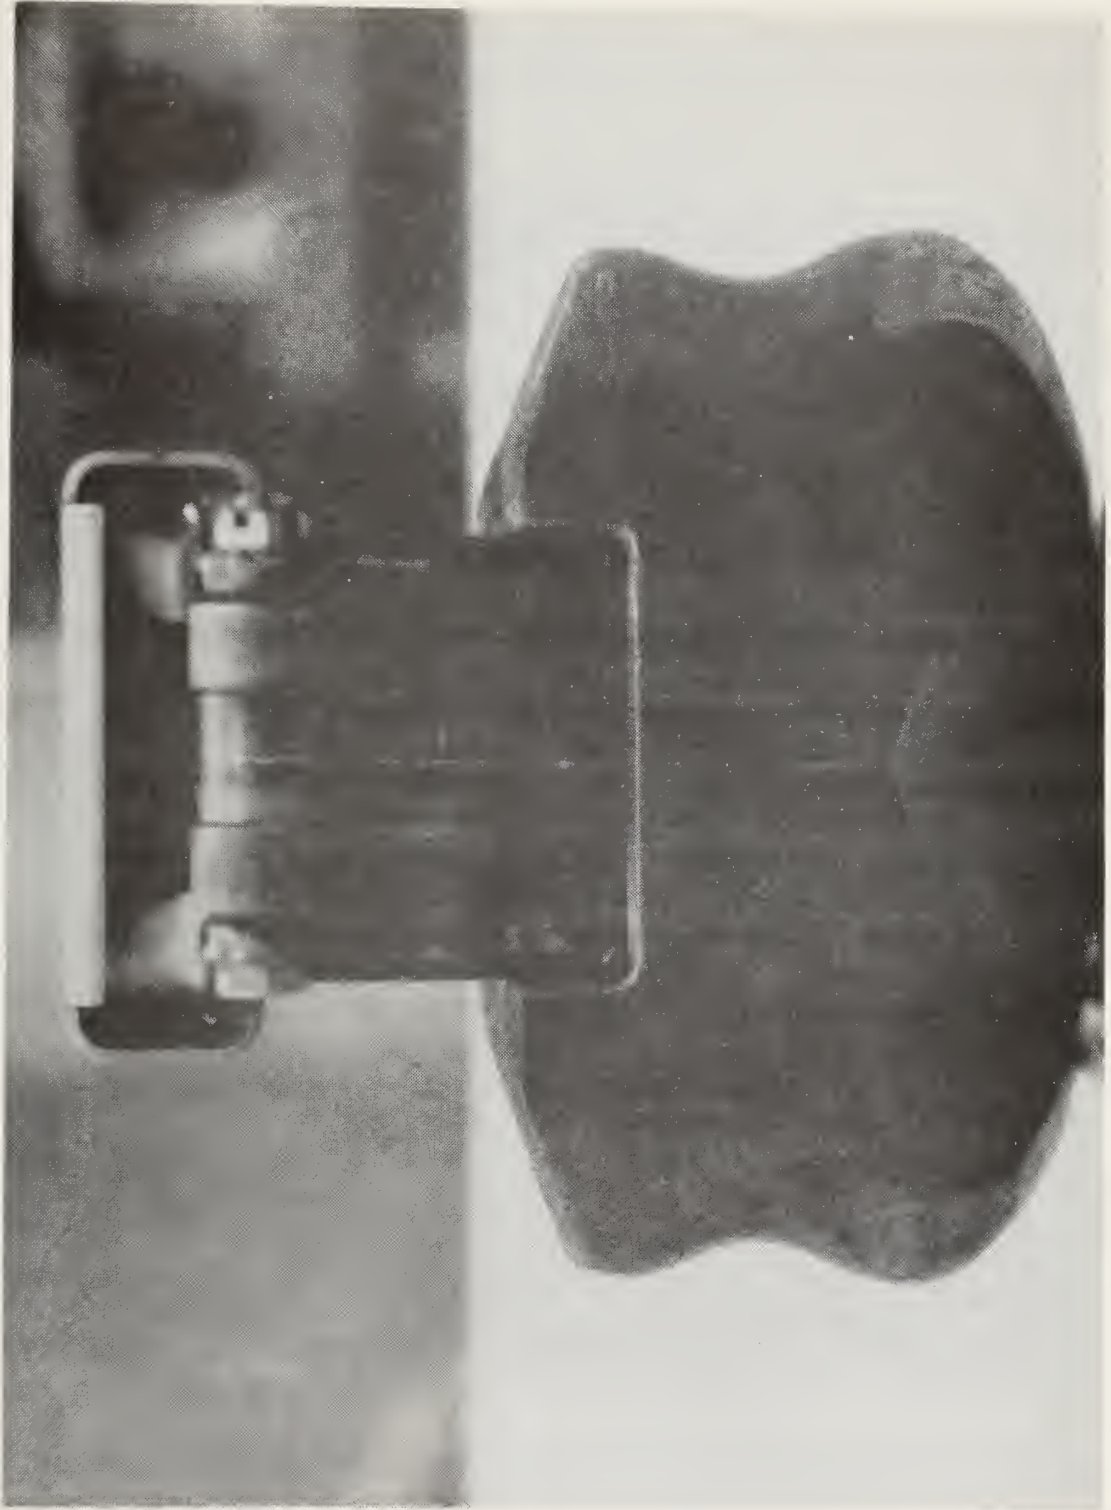
Figure 5. Back view of hook point-boss joint showing the hook point flanges fitted on each side of the shank to prevent rotation about the boss.

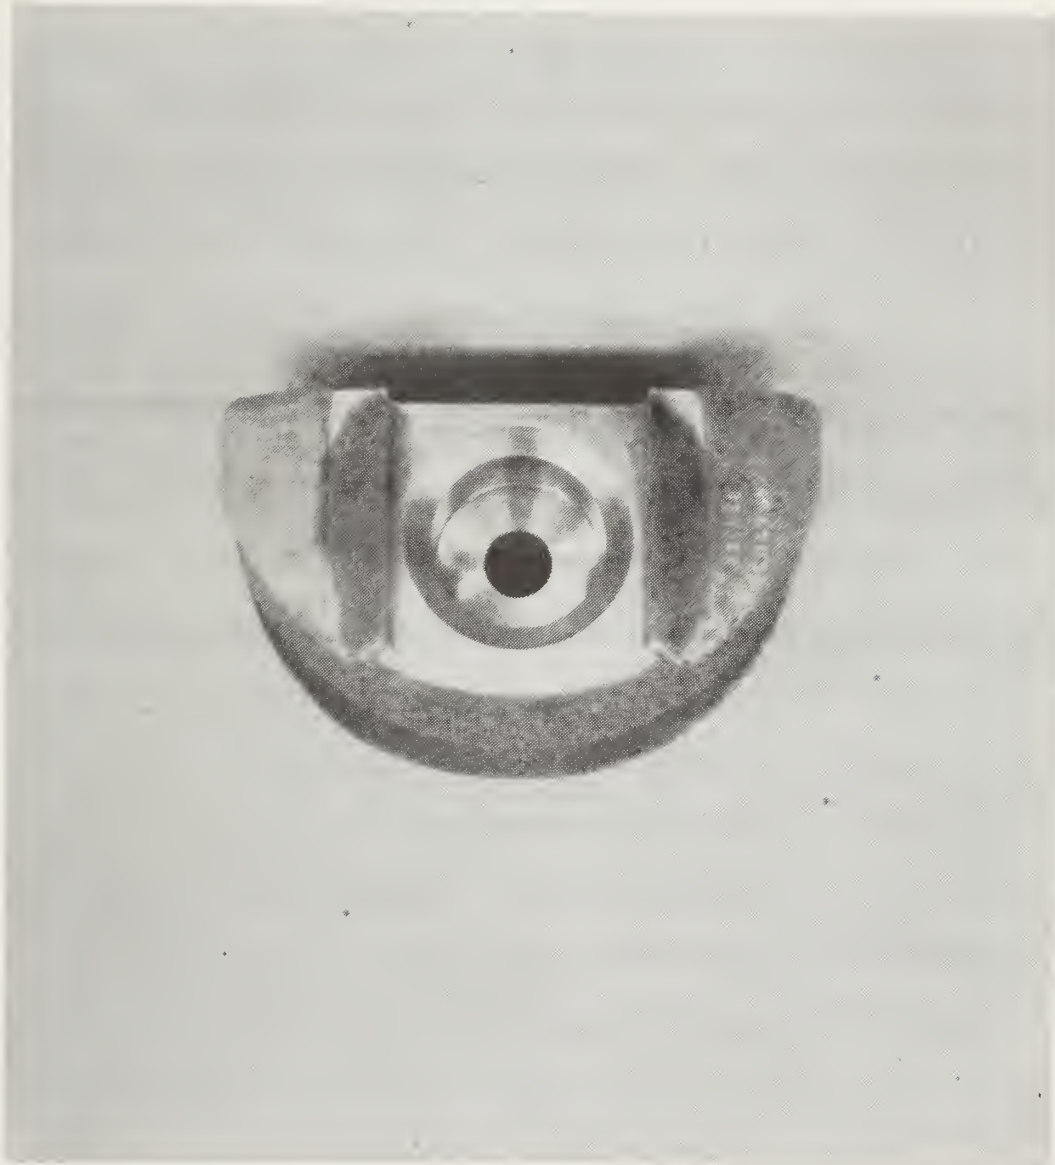
Figure 7. Top view of hook point showing the boss receptacle.

groove which, due to its position relative to the shank boss, transfers all of the impact loads to the shank boss (Fig. 7). In contrast the "shovel nose" point, due to its geometry (Fig. 10), has more of an opportunity to hang up on the edge of the nose where loads other than design loads could be imposed on the attachment bolt (Ref. 4). The relative position between the shank boss and front edge of the new hook point (Fig. 10) is such that it allows the possibility of significant rotational moments and tensile loads as well as shear to be applied to the hook point bolt-nut joint (Ref. 4,5) during arrestment or impacting of deck obstructions. Naval Air Rework Facility, North Island, during an engineering investigation, requested in Reference 6, of an A-7 attachment bolt failure reported that separation was initiated by the imposition of a fore and aft rotational moment which induced tensile, bending, and shear loading on the attachment bolt (Ref. 7). Any excessive clearance between shank boss and hook point receptacle or looseness in the joint greatly enhances the possibility of failure by allowing even more of the impact load to be imposed on the bolt.

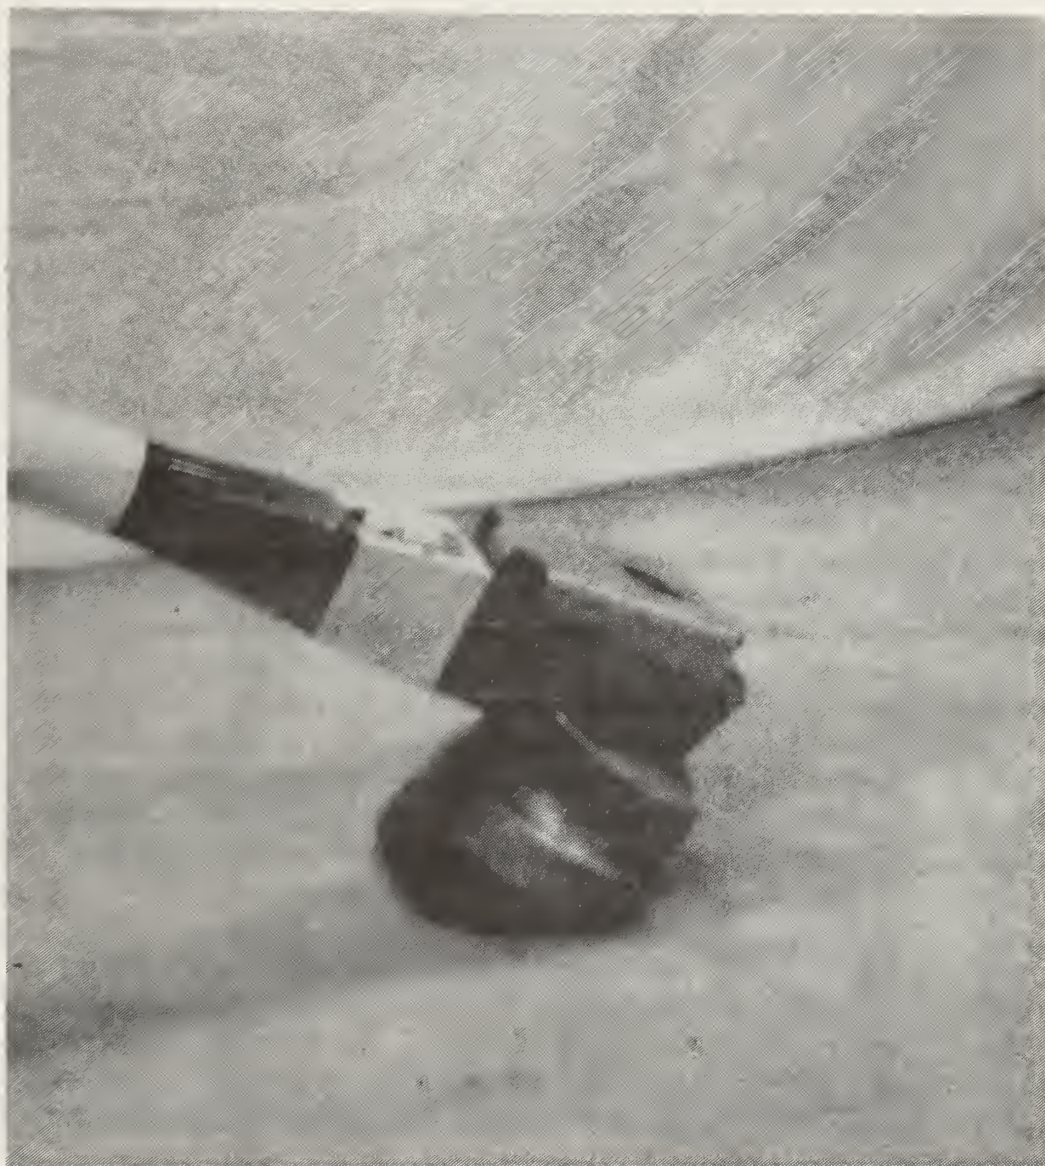
Figure 8. Actual attitude of arresting hook before wire engagement.

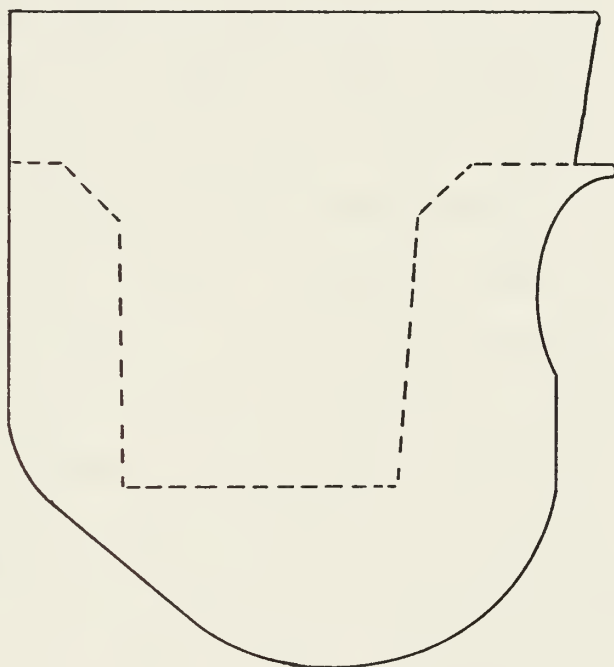
Figure 9. Old "blunt nose" hook point.

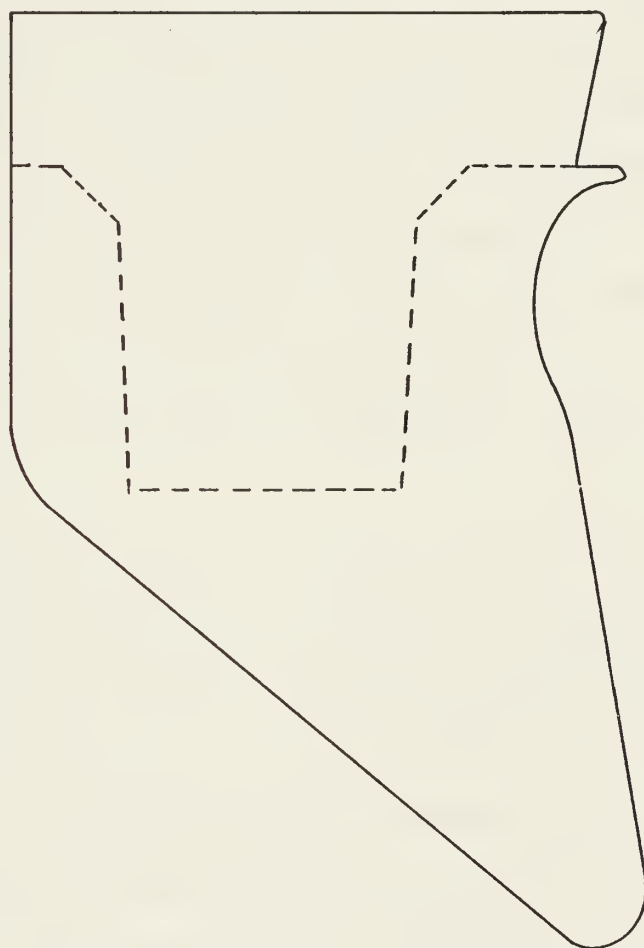
Figure 10. New "shovel nose" hook point.

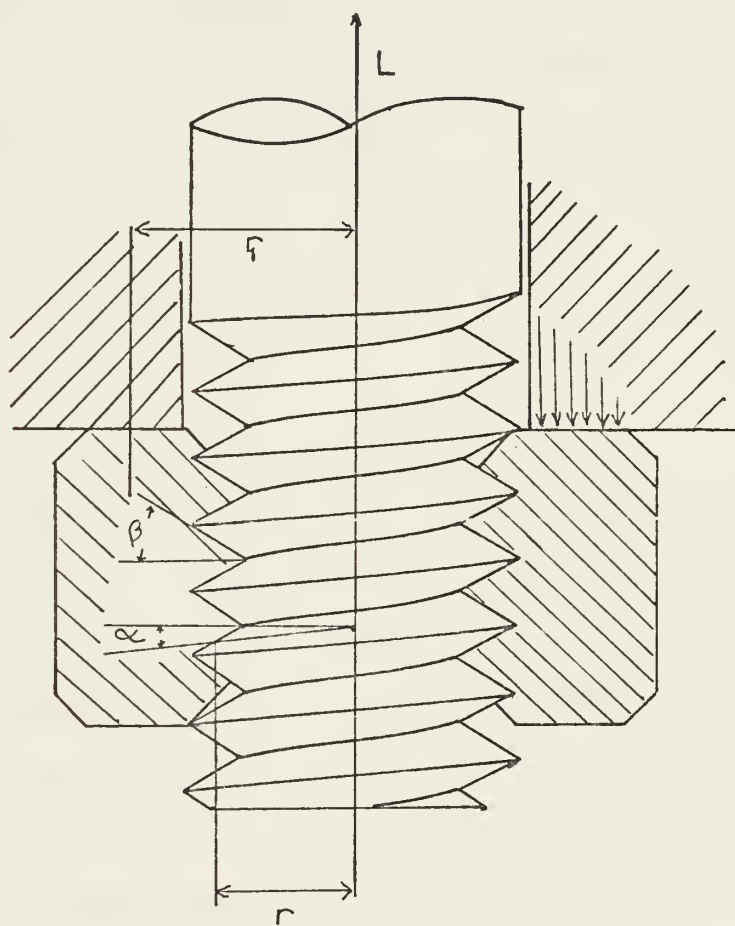
The nut and bolt assembly showing the helix angle α , pitch diameter r , effective base radius r_1 , and the thread form angle β is presented in Fig. 11. In order to describe the forces exerted on the threads of the bolt in a loaded condition, a coordinate axis transformation is necessary. The initial coordinate system with one axis in the bolt axial direction, unit vector \hat{j} , the second axis in the radial direction, unit vector \hat{i} , and the third axis in the circumferential direction, positive in the tightening sense, unit vector \hat{k} , must be transformed into a system with unit vectors \hat{i}'' , \hat{j}'' , \hat{k}'' , where the \hat{j}'' axis is normal to the thread surface, the \hat{i}'' axis is tangent to the thread surface in the radial direction, and the \hat{k}'' axis is tangent to the thread surface in the

Figure 11. Parameters used in the nut and bolt assembly.

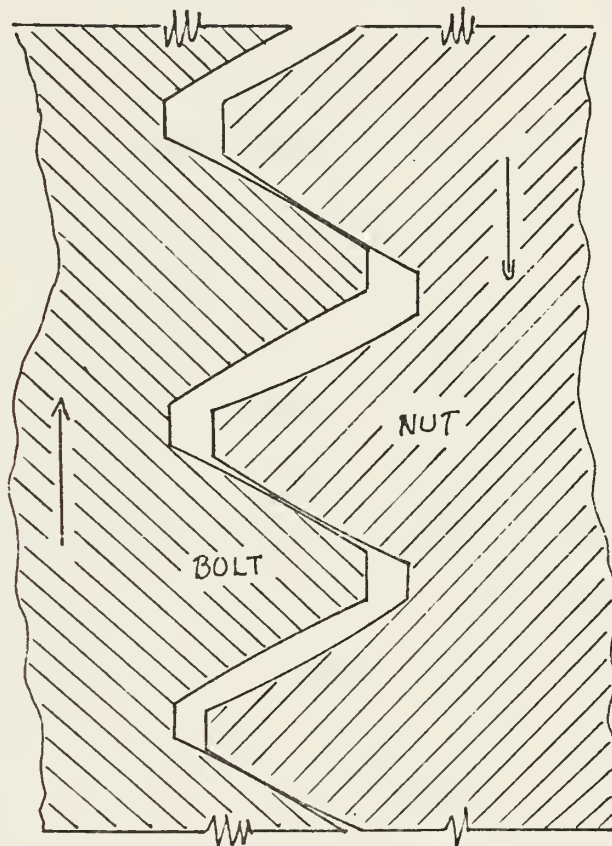
The essential element of the self loosening mechanism is the motion of the nut when the bolt is subjected to a load. Initially the transfer of the applied load to the nut is concentrated near the base with relatively small pressures near the free end of the nut (Ref. 25,28). This action of the nut causes the thread bearing pressure to be concentrated at the base end of the nut during initial loading (Ref. 26,28). Typically the bolt is in tension and the nut is in compression, and as the load on the bolt increases, the bolt tends to contract radially due to the Poisson effect and the nut being further compressed tends to expand radially due to both the Poisson effect, and the thread form angle β . The radial component of the bolt load on the nut due to β tends to expand the nut wall radially, and as the nut expands, the threads at the base are deflected as cantilever beams (Fig. 12) causing further expansion of the nut. The expansion of the nut is greater at the base than at the free end as is shown in Fig. 13,

Figure 12. Deflection of the bolt and nut threads under a load.

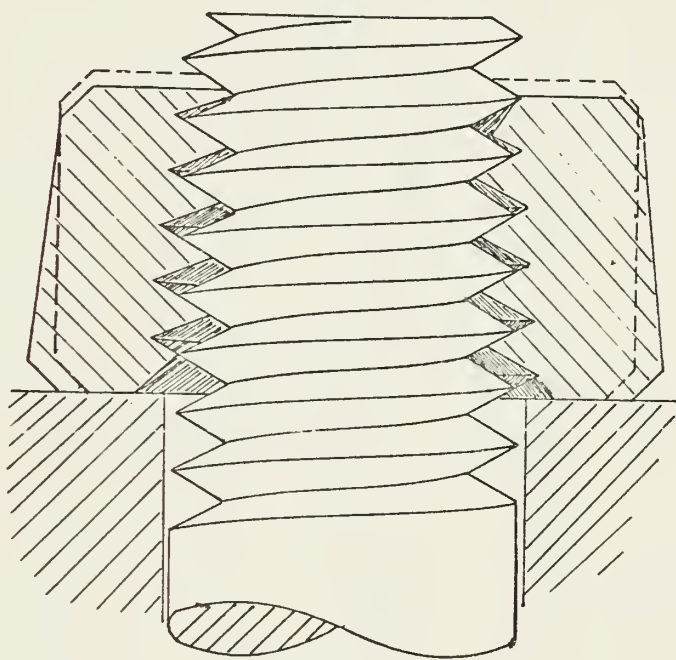
and at higher loadings the thread bearing pressure is more evenly distributed throughout the nut length due to the uneven expansion. The distortion of the nut tends to concentrate the base reactions near the inner radius of an initially flat base due to the upward pull of the threads (Fig. 13) and the downward reaction of the base acting on different radii, and this results in a reduction in the effective base friction radius.

Figure 13. Nut under a load showing its radial expansion.

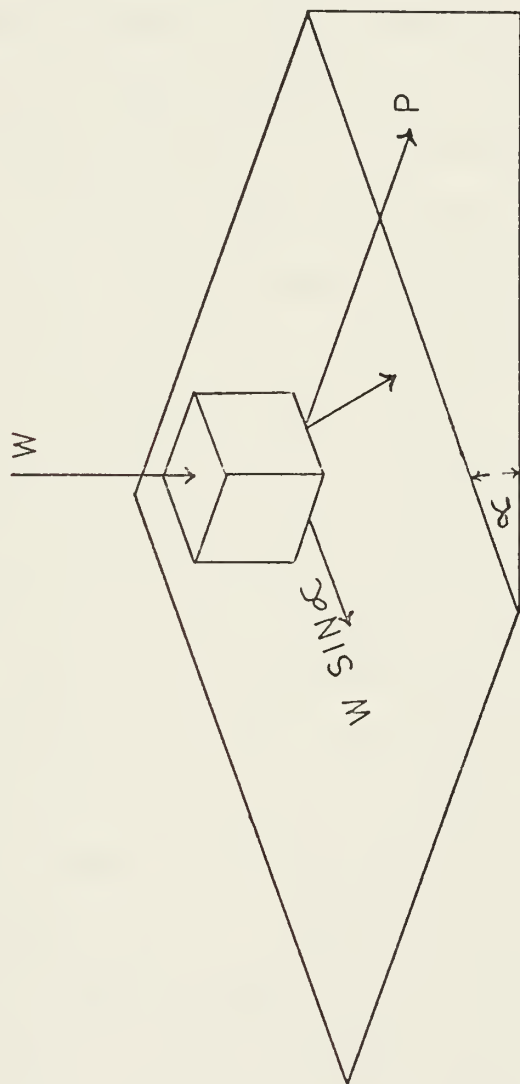
A simple example of the above physical law is a block on an inclined plane. The weight of the block in Fig. 14 is not

Figure 14. Motion of a block on an inclined plane with only gravity and a side load acting on it.

sufficient to overcome the friction force unless the component of weight parallel to the inclined plane $F_w = W \sin \alpha$ is greater than the friction force, $F_F = W \cos \alpha \mu$, where W is the weight, α is the angle of the inclined plane, and μ is the coefficient of friction. Now if a side force, P , is introduced and is large enough to overcome the friction force and cause the block to move in the sideways direction, the block will not only move sideways but will also move down the inclined plane as indicated in Fig. 14. The downwards motion is due to the component of the weight that was initially too small to produce motion. An analogous effect takes place in a threaded fastener when cyclic loading or vibration has created relative motion in the bolt-nut joint. The loosening torque which was initially too small to overcome the friction torque now is acting on an essentially frictionless surface and will cause the nut to rotate in the off direction, and self loosening occurs. Total self loosening occurs when the nut rotates enough to release all of the torque preload previously applied and partial self loosening results when some of the preload is released but some still remains.

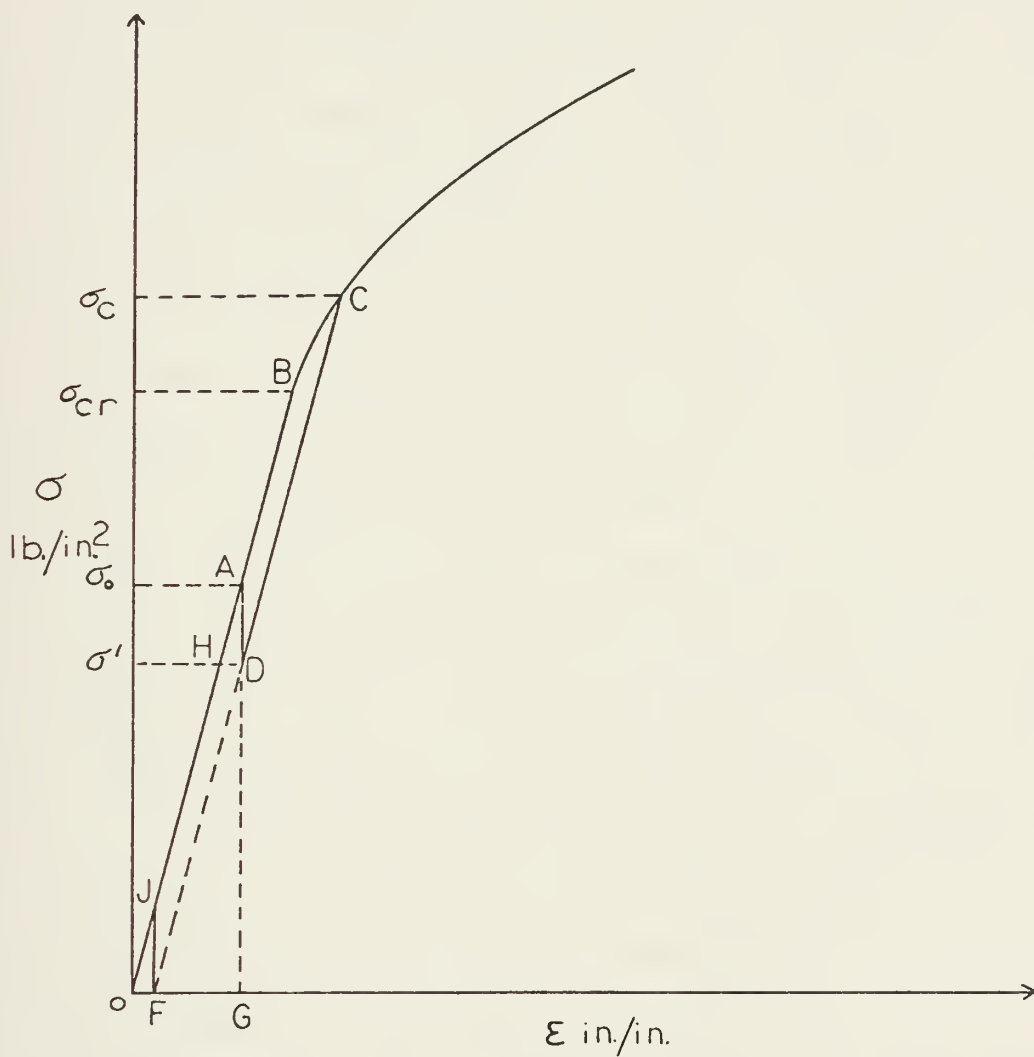
The question is, how much of the clamping force due to the original torque preload is lost when the bolt is plastically strained? First assume the bolt has been stressed to point A

Figure 15. General stress strain diagram.

in Fig. 15 by the torque preload. Now some external force causes the stress to increase past B to C. When the external force is released, the stress will diminish along line CF, as described above. If it is still assumed that the clamped parts are essentially incompressible, the stress will decrease until the strain is equal to the initial strain OG in Fig. 15, i.e. until the distance between bolt head and nut is the same as it was after the initial torquing. Now, however, the total strain is composed of an elastic part, FG, and a plastic part, OF. The latter contributes nothing to the clamping force.

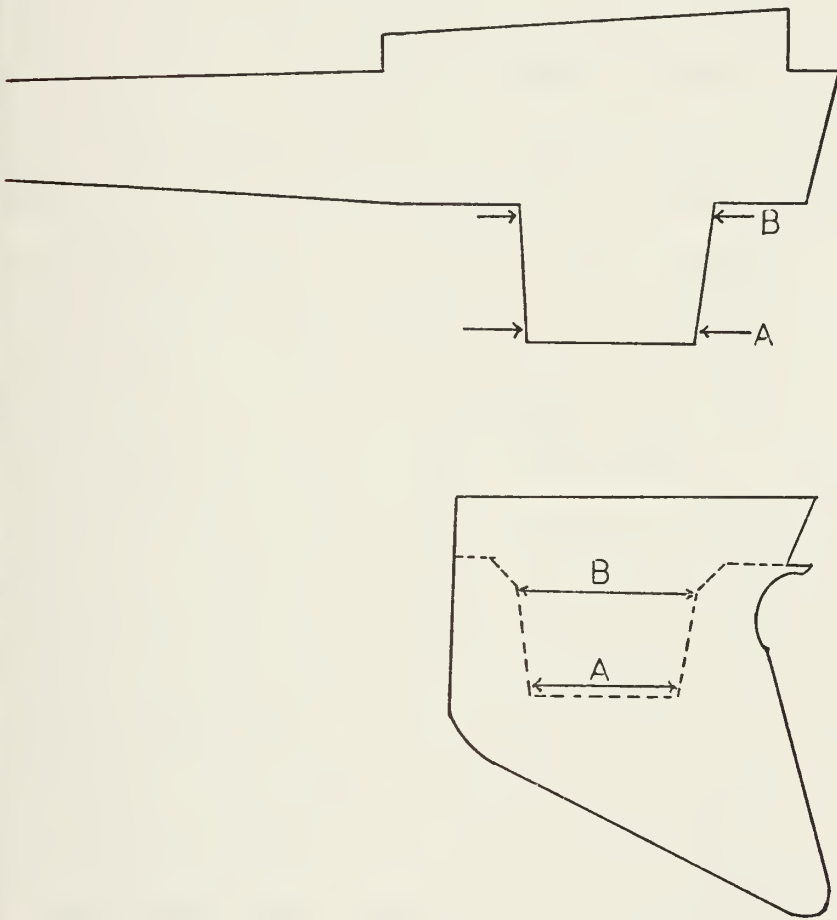
Figure 16. Positions measured on the boss and the hook point receptacle.

and the measurements of a new hook point were: Diameter A in Fig. 16, corresponding to diameter A of the shank, was 1.9015 inches and diameter B was 1.9035 inches. Upon inspection of the loosely mated parts, the hook point could be made to rock back and forth, pivoting about the end of the boss. The hook point could also be made to rotate slightly with the boss acting as its axis of rotation. These motions were accomplished by hand force alone with the bolt sitting loosely in its seat. Thus the possibility of relative motion between hook point and shank boss exists in the arrested landing.

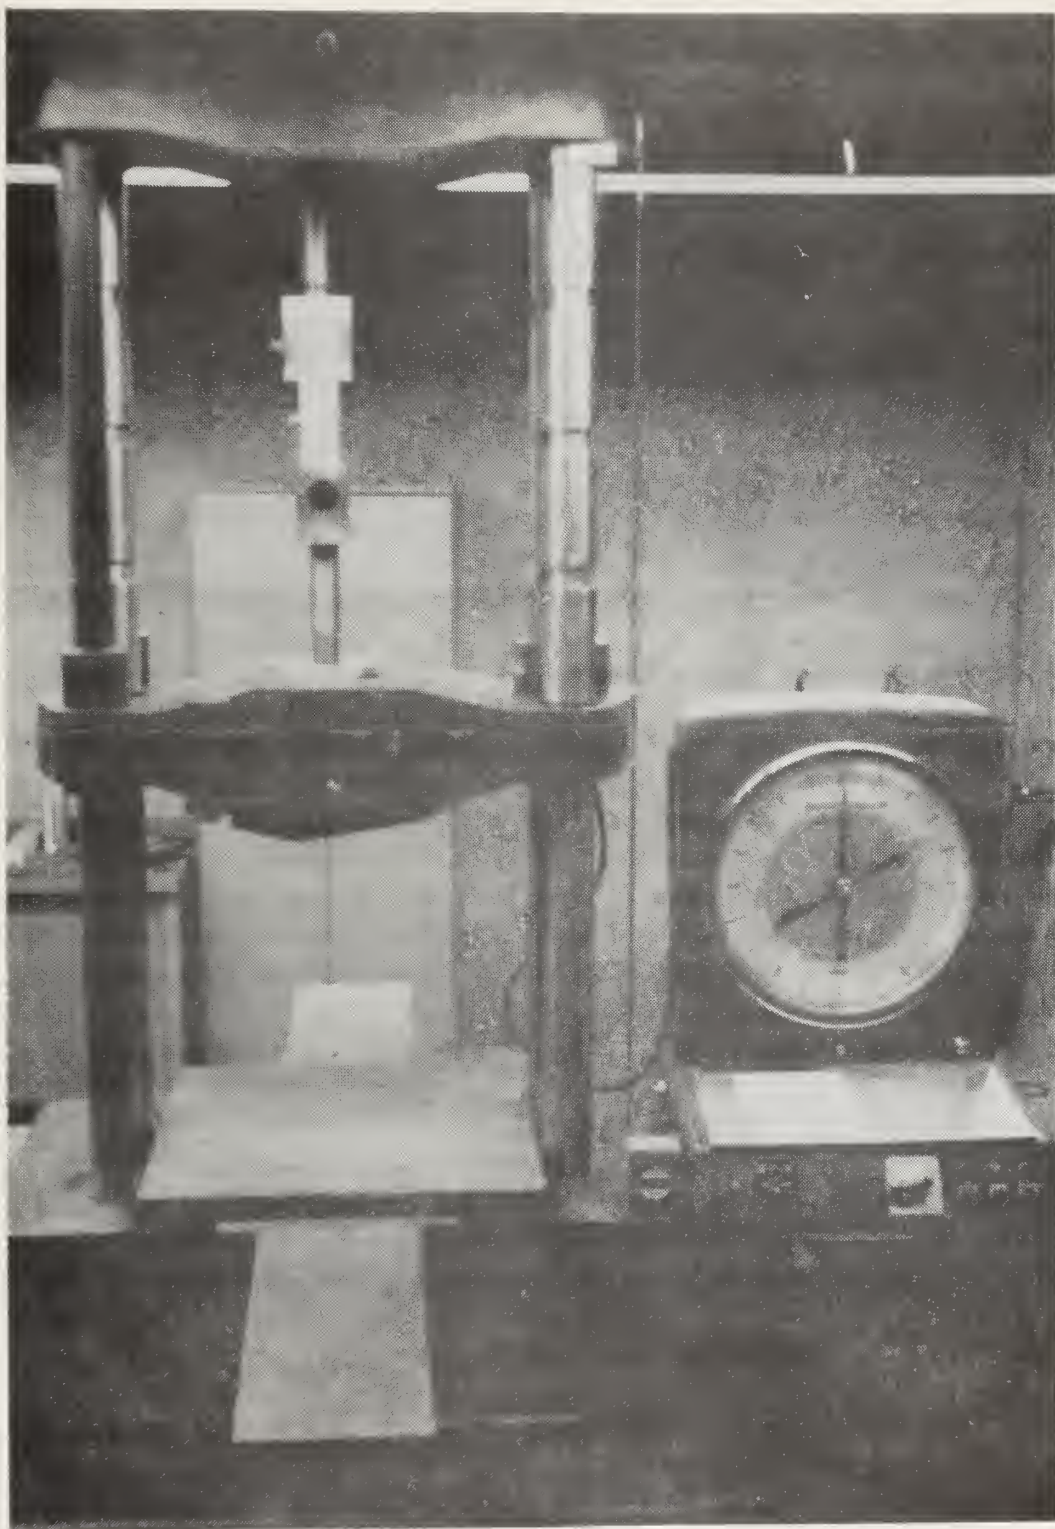
Figure 17. Riehle model PS-300 test machine with test fixture in place.

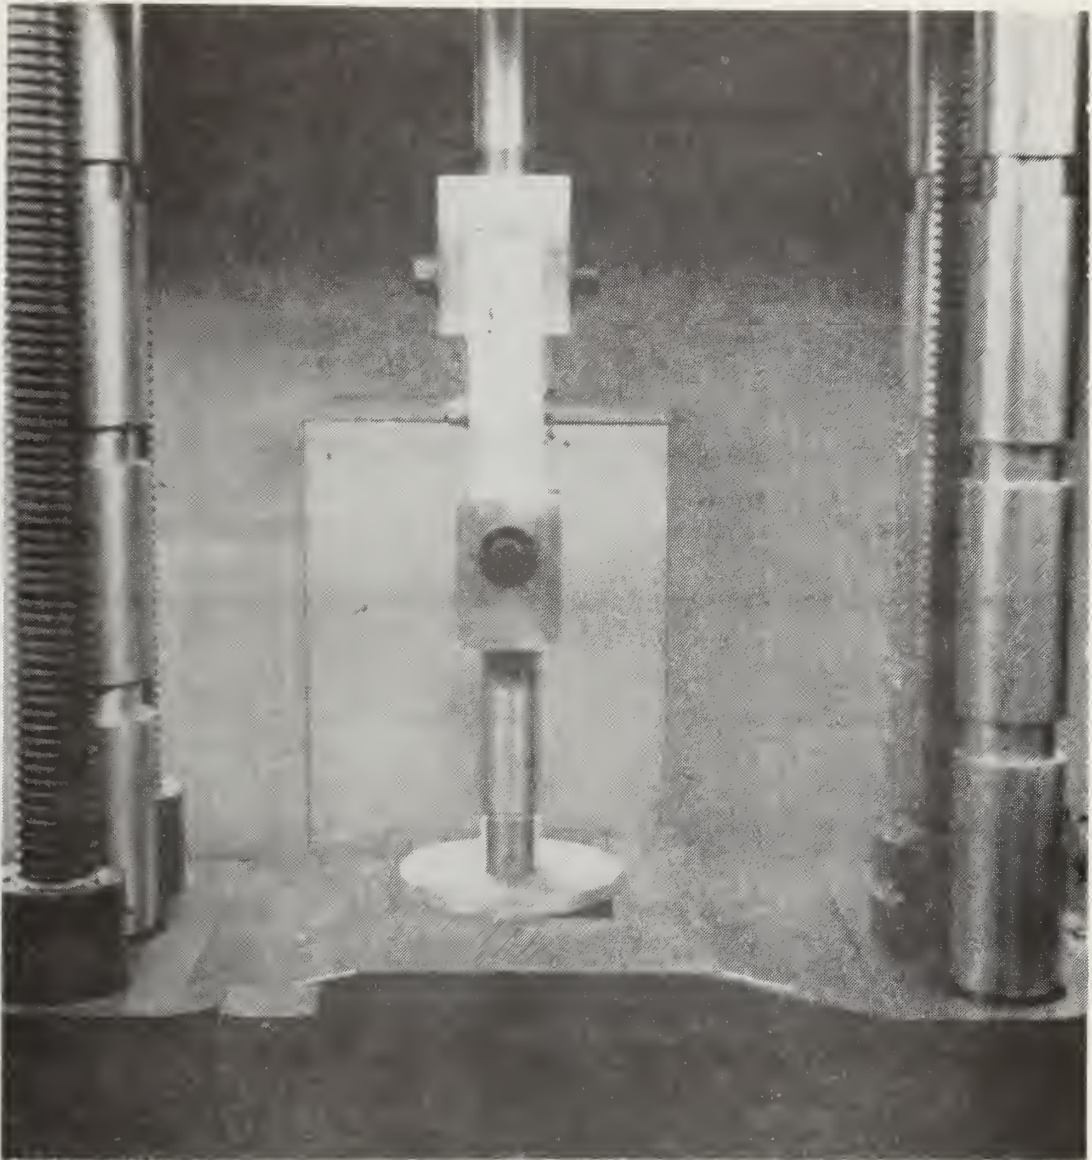
Figure 18. Riehle test machine crossheads with fixture attached.

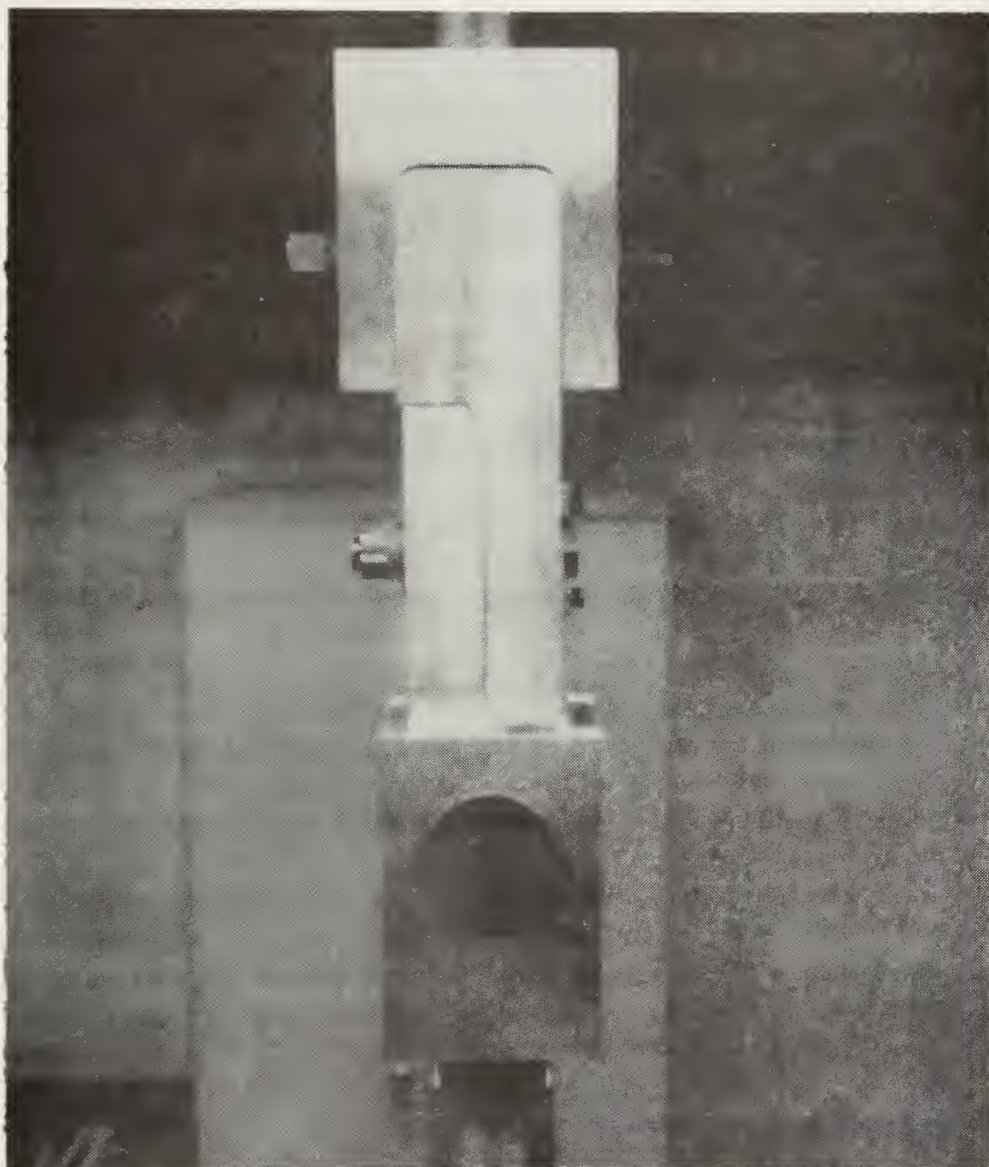
Figure 20. The test fixture.

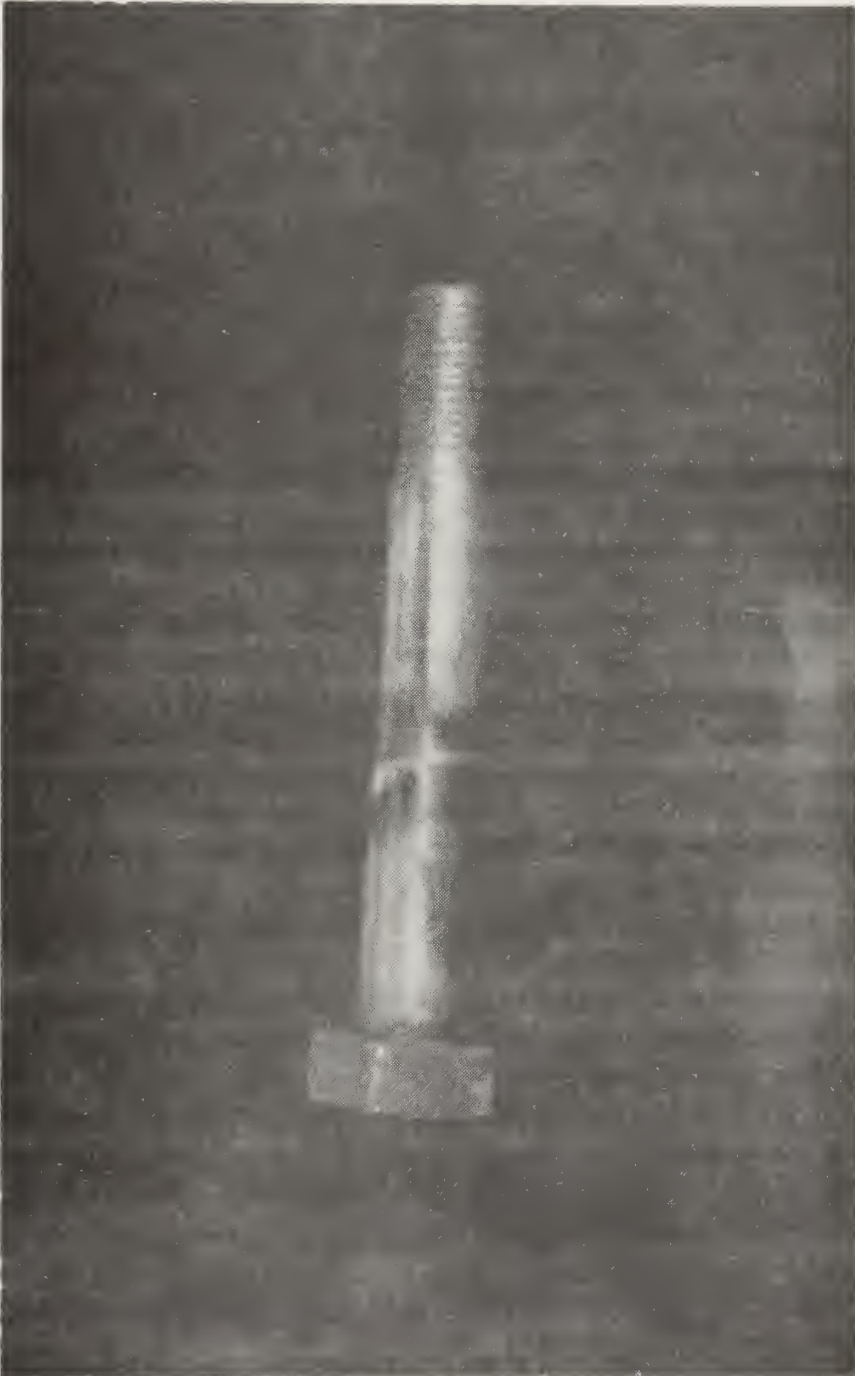
Figure 21. Bolt showing shear deformation incurred during testing.

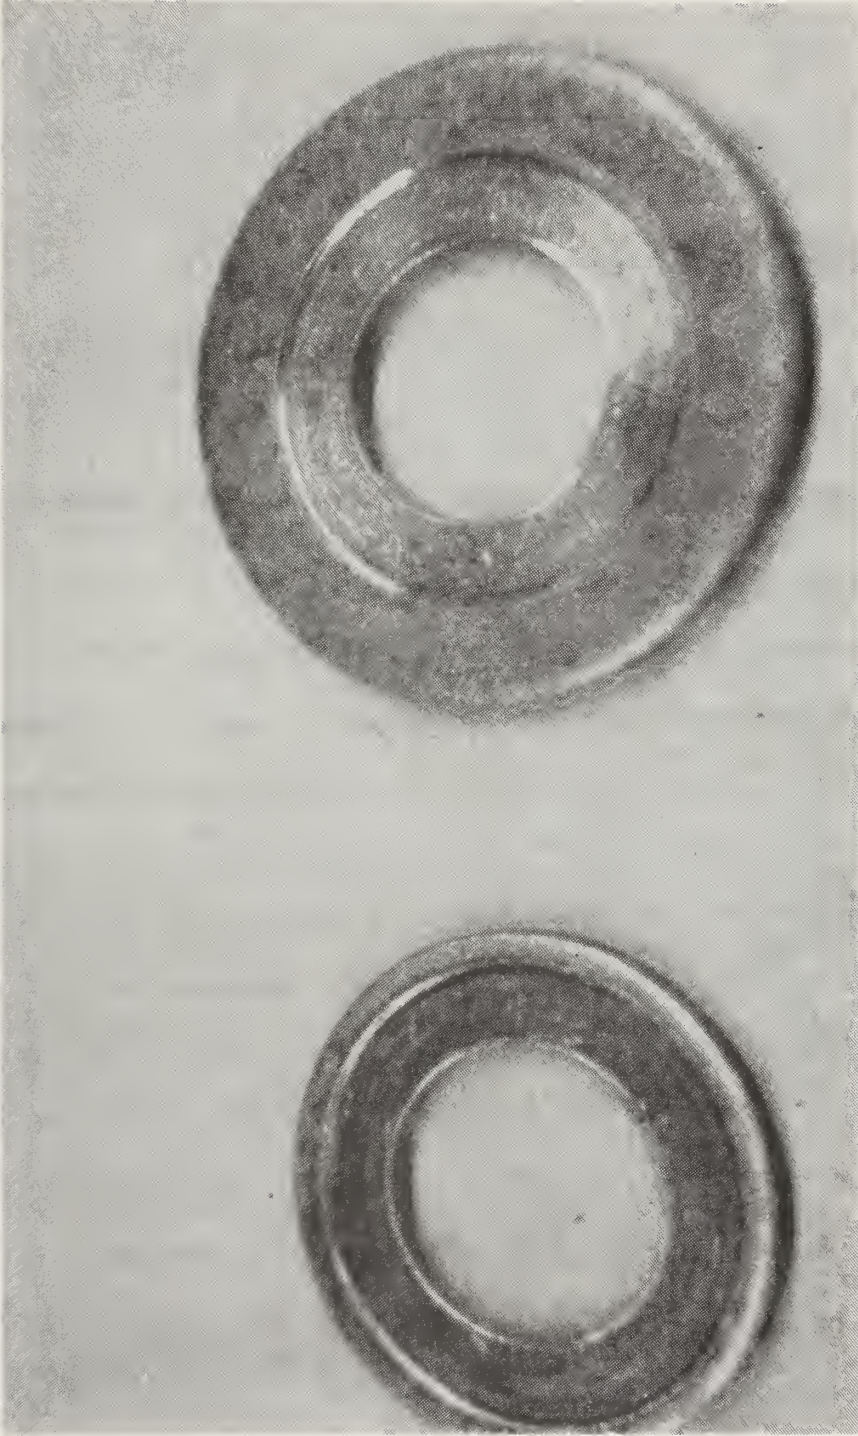
Figure 25. The two crushed washers in Series "C".

b. only high-strength (hardened) steel washers be used in the hook retaining assembly.
